中美和公司台中廠興建計畫  
環境影響說明書申請備查內容  
(新建備用成品儲槽)

開發單位：中美和石油化學股份有限公司  
中 華 民 國 1 0 6 年 1 2 月

# CAPCO TCP Product Silo Inspection Report

# AF610B PTA Product Silo Internal Inspection report

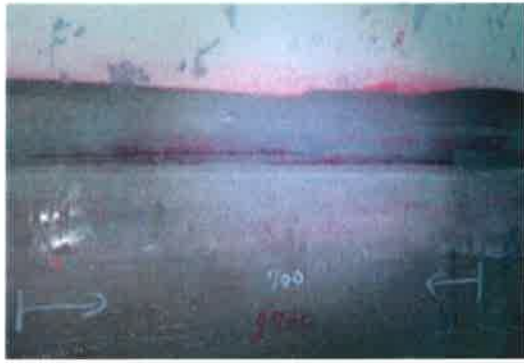
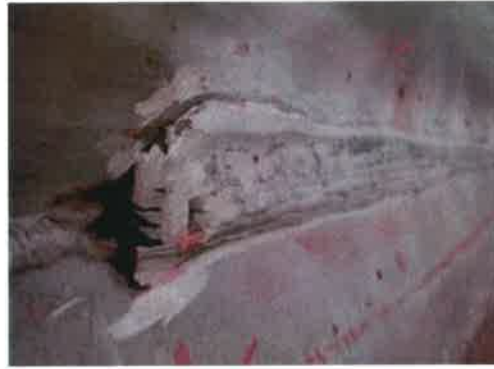
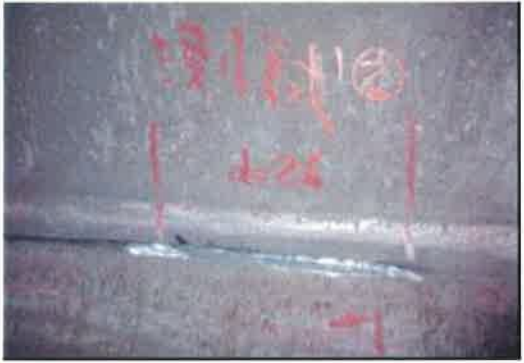
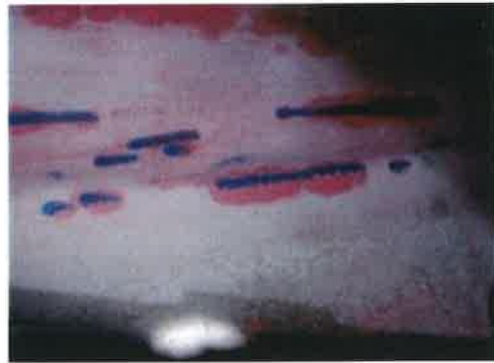
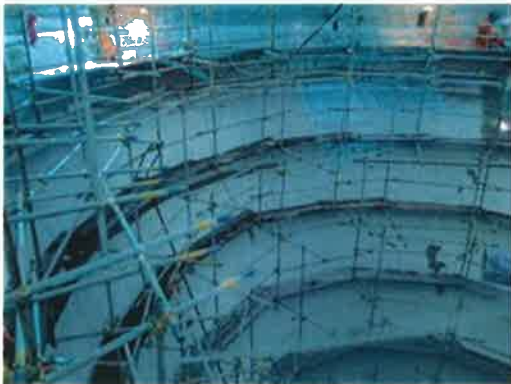
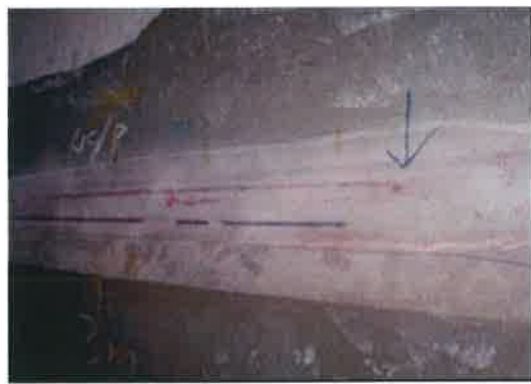
台中廠現有成品儲槽和大陸珠海廠約為同時期以相同鋁製材質製造，經十多年使用，發現槽壁外部裙座表面補強肋條焊道及內部檢查發現不同高度位置圓周焊縫有多處龜裂，其中椎角和直部圓周焊縫處共有 31 處龜裂(圖 1、圖 2)，總龜裂長度 27 公尺占 53 公尺圓周的 52%。這些損壞現象與大陸珠海廠完全一致。由於發生龜裂範圍廣泛，中美和目前僅能侷限針對重要位置進行修護，操作中觀察桶槽仍出現桶槽

圖 1. 成品儲槽內部搭架檢查修理焊道龜裂情形

漏粉現象。目前本廠暫時使用填縫材料在外部將洩漏處封住止漏，以避免洩漏進一步擴大，但為了避免因設備嚴重損壞所產生之安全顧慮，必需要有長期維修計畫，否則其發生粉體洩漏、設備斷裂倒塌之風險將越來越高。因原儲槽須排空檢修，為了使現有損壞的成品儲槽在維修期間，能持續供料給客戶，因此規劃新增儲槽當成品備用儲槽。

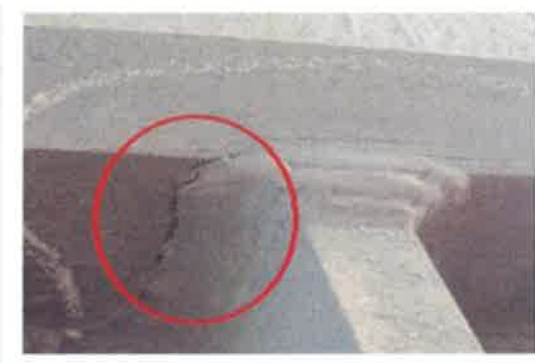
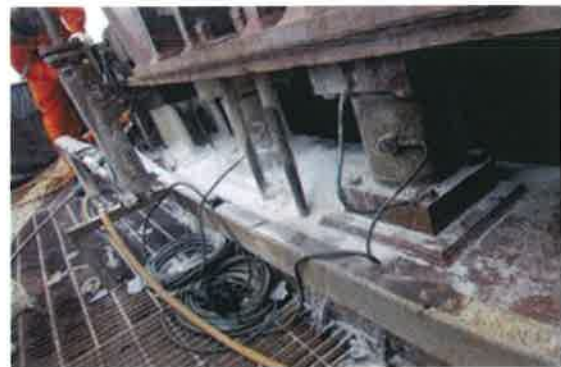
圖 2. 成品儲槽外部焊道龜裂情形及漏粉位置

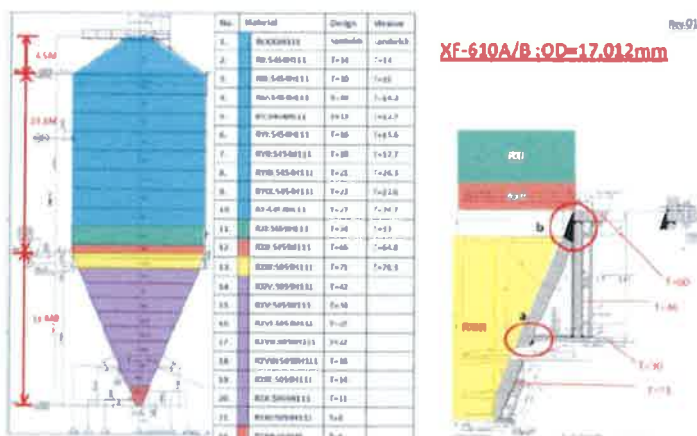
1. 經內部檢查發現成品儲槽(XF-610B)在“a”位置發現滲漏和焊縫裂縫。這很可能是焊縫“b”已經產生裂縫了。在焊縫“b”上發現了三種不同的圓周裂紋(I, II, III)。
2. 槽壁鋁材外部圓周向補強肋條位置、焊縫與板材有31處出現龜裂，總龜裂長度27公尺占53公尺圓周的52%。
3. 最長的連續裂縫長度接近3m。
4. 最深的裂縫約48毫米。
5. 此設備若未整修而繼續使用，其發生粉體洩漏、設備倒塌之風險將越來越高。目前本廠暫時使用填縫材料在外部將洩漏處封住止漏，避免洩漏進一步擴大，但為了避免因設備嚴重損壞所產生之安全顧慮，必需要長期維修。

- There were leakage and weld seam crack finding at "a" position before TAR. It was very likely the weld seam "b" had crack already.
- This job scope is focus on weld seam "b" inspection and repair.

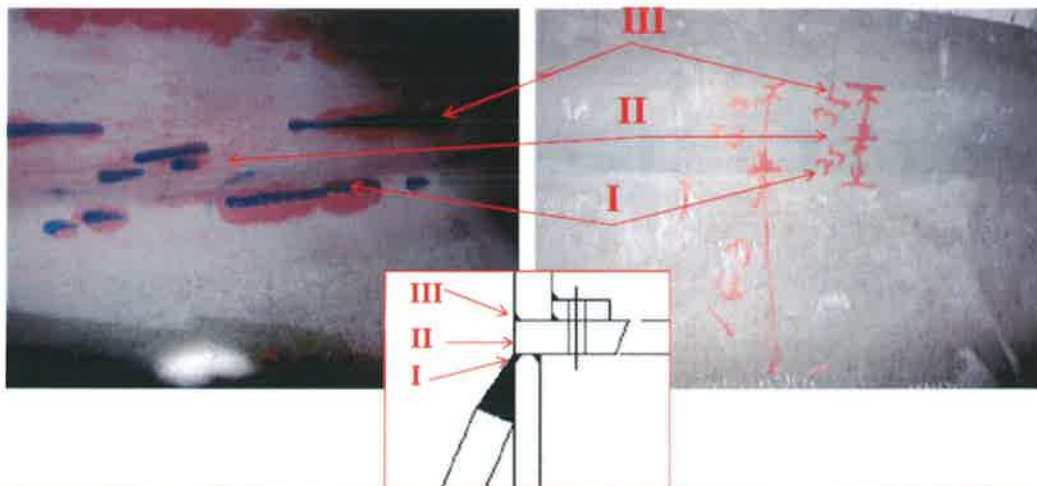
There were three different circumferential cracks finding ( I,II,III) on weld seam "b".

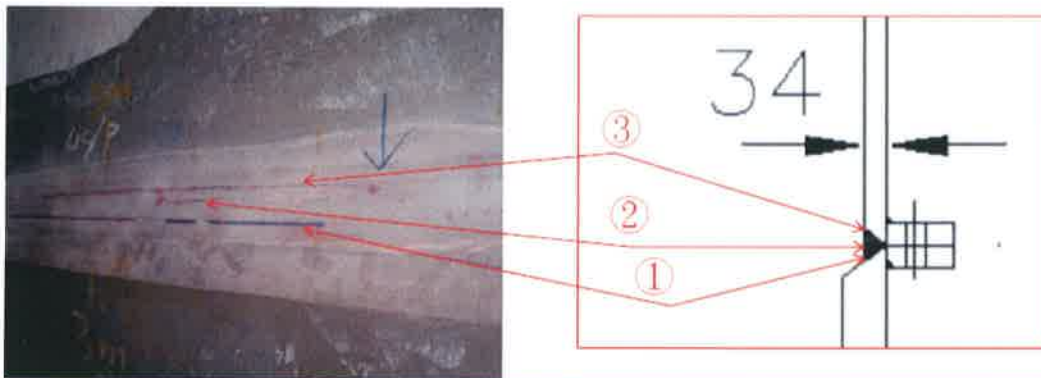
- Weld seam no. "C" showing on weld seam layout DWG, which is below "b" 's 1st circumferential weld seam. 9.32 m long was inspected by PT without defect finding.
- Weld seam no. "A" showing on weld seam layout DWG, which is upper "b" 's 1<sup>st</sup> circumferential weld seam.

\*There are also different circumferential crack finding on "A" , like ①②③

\*About 50% of defect finding of a circle circumferential weld seam ① , it have not been repaired this time.

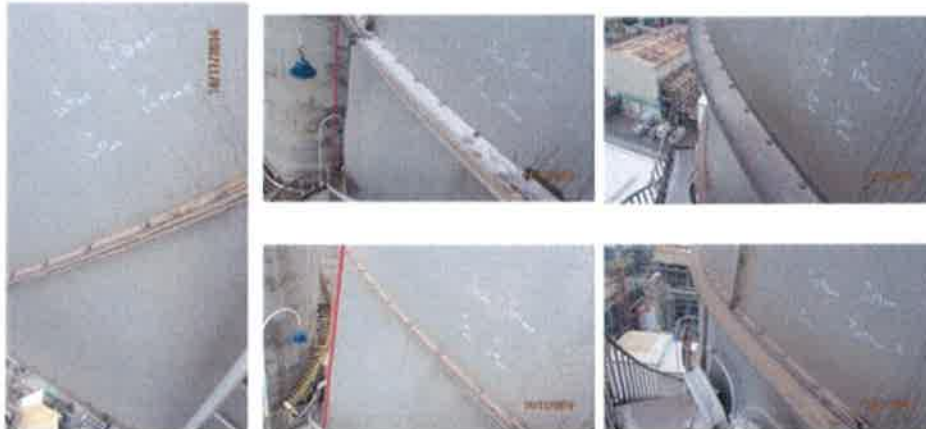
Shell plate thickness is in normal condition

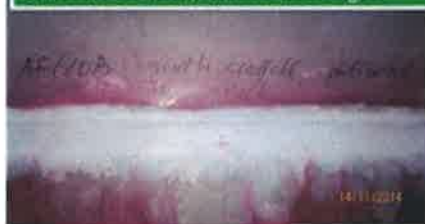
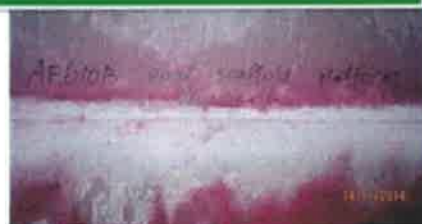
RX/RMI shell plate joint circumferential weld were checked by PT. No cracks and other defect were found by random check, 4 \* 2000mm, 4 scaffold platform, 4 directions, east/south/west/north, 90/180/270/350 degree.

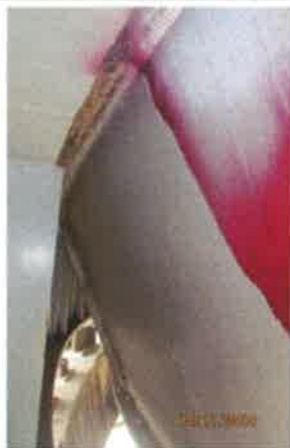
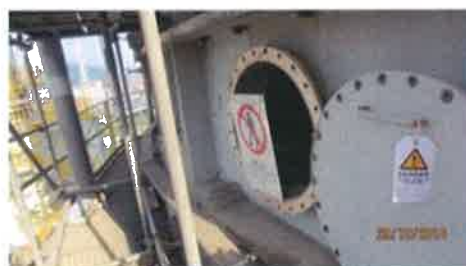
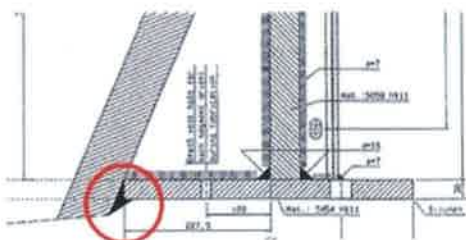
RXIII cone plate support circumferential weld were checked by PT. No cracks and other defect were found.

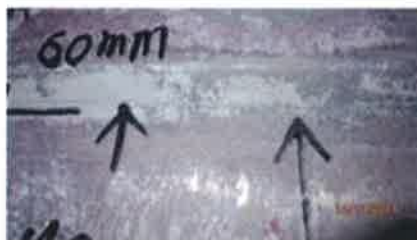
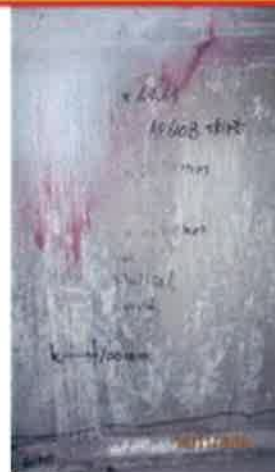
Condition of the 2nd longitudinal weld(RXII/RXIII) section : no cracks were found in vertical weld, but circumferential weld is in whole section cracks.

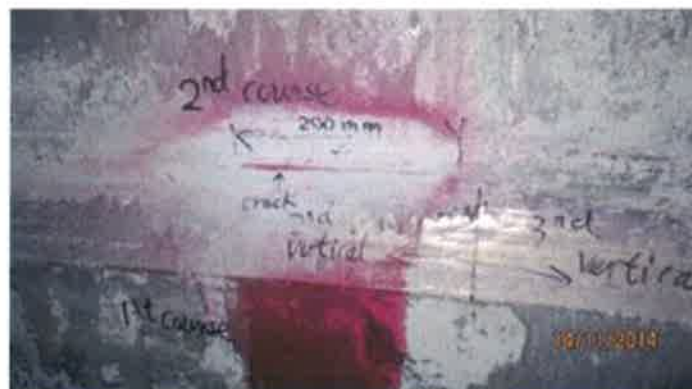
Condition of middle of the 2nd/3rd longitudinal weld(RXI/RXII) section : no cracks were found in vertical weld, but 200mm length cracks were found in circumferential weld, up in AL skirt weld, the only cracks in RXI/RXII circumferential section

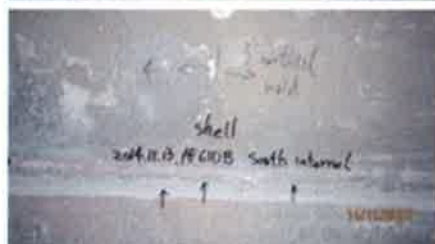
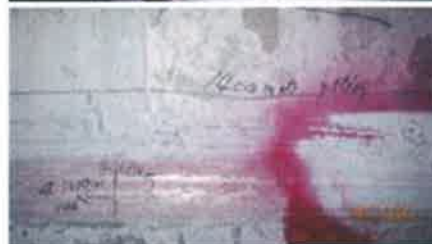
Condition of the middle of 4/5 longitudinal weld(RXII/RXIII) section : circumferential weld is in whole section cracks, many pitting were found in upper circumferential weld, length is about 1400mm, biggest depth is about 2mm, width is about 50mm.

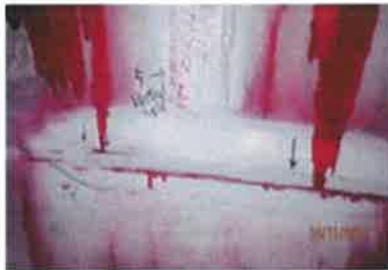
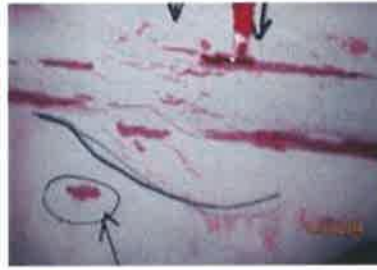
Condition of the 5th longitudinal weld(RXII/RXIII) section : no cracks were found in vertical weld, but circumferential weld is in whole section cracks. The cracks was complex and 2 or 3 layer cracks may be seen.

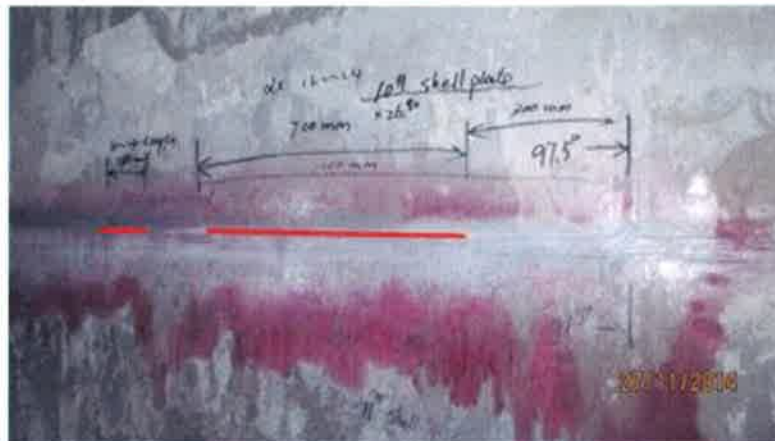
RX/RXI 10/11 section: many continuing cracks were found in 2 meters length by UT test, 97.5 degree direction, east of the silo. The depth is about 16—24mm from internal surface, defect is near upper fusion line, continuing length is 190/140/700mm. 4 scaffold platforms service, the other 3 platforms no defect found, defect only in eastern scaffold platform.

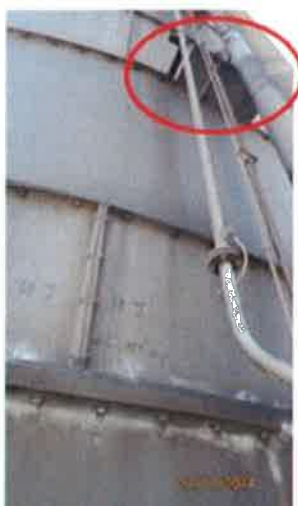
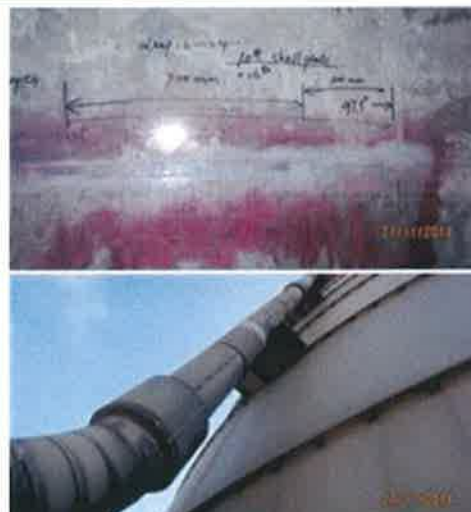
RX/RXI 10/11 section: There is a pipe support outside the shell in the same 97.5 degree.

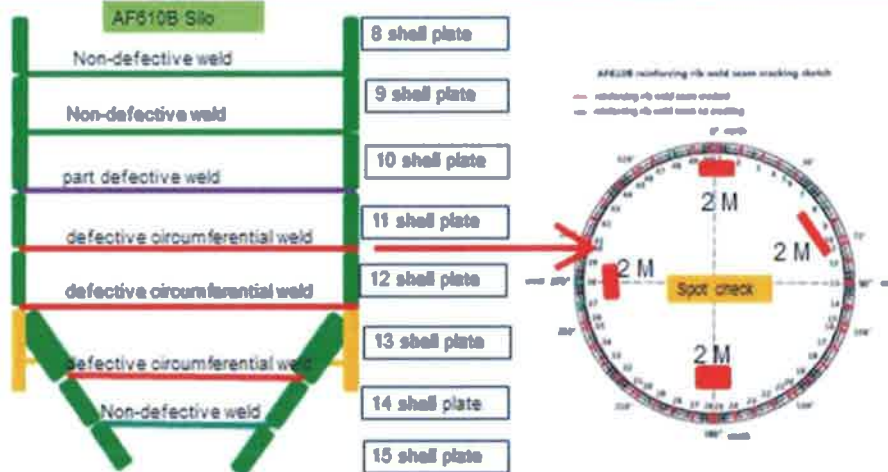
RXII/RXII 11/12 section: Spot check 2\*4=8 meters by UT test, as marked in red location. Complex defect of crack were found in each direction. The depth is about 17—24mm and 26—32mm from internal surface, defect is near down fusion line, continuing defective length is 170/200/150/400/200/1300/170/100/2000mm.

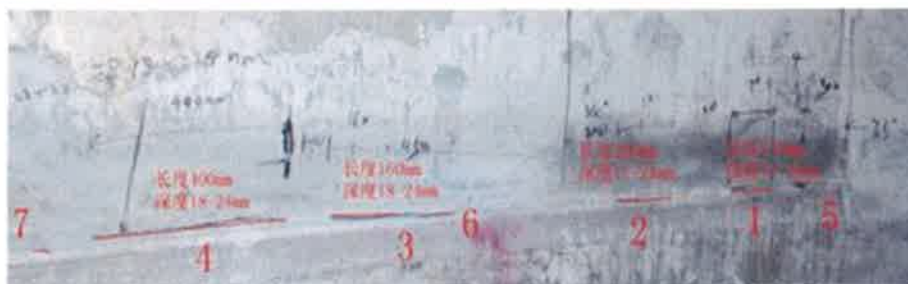
RXII/RXII 11/12 section: discontinuing cracks were found by UT test, from 350—360—7.5 degree direction, north of the silo. The depth is about 17—24mm from internal surface, defect is near down fusion line, continuing defective length is 400/160/200/170mm as marked No1—4 in upper picture, location is 10mm from lower fusion line. No 5—7 is very short.

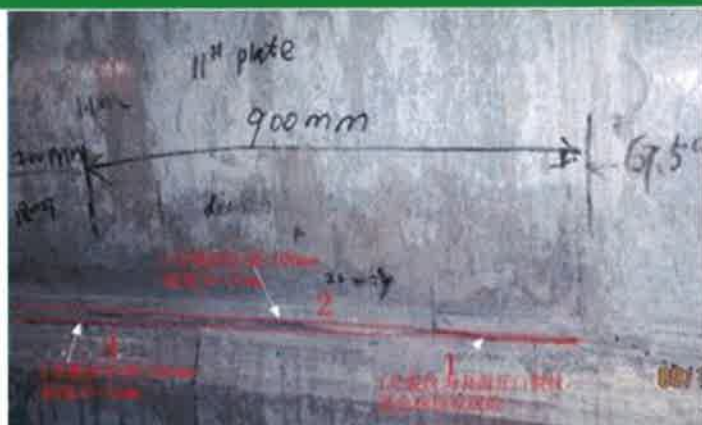
RX/RXII 11/12 section: continuing cracks were found by UT test, from 60—67.5 degree direction, north-eastern of the silo. One surface defect was found by PT, depth is about 0—29mm from internal surface by UT, defect location is 10mm from lower fusion line, continuing length is 200mm as marked No1. No2 defect is continuing 1100mm from 60—67.5 degree, depth is 18—27mm, defect location is 10mm from lower fusion line. No3 defect is continuing 1300mm from 60—67.5 degree, depth is 26—32mm, defect location is near down fusion line.

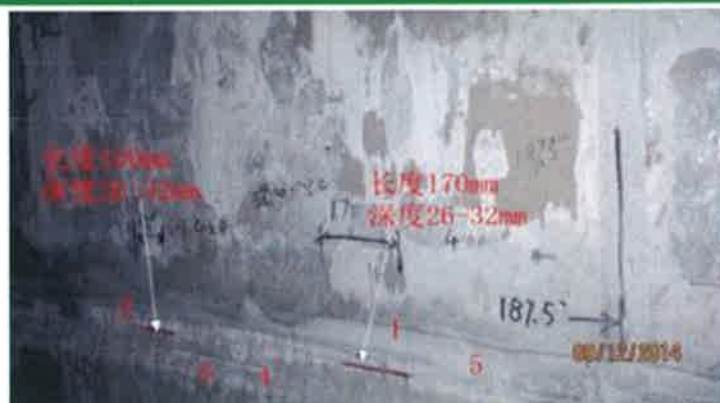
RX/RXII 11/12 section: continuing cracks were found by UT test, from 180—187.5 degree direction, south of the silo. No1 defect is continuing 170 and depth is 26-32mm, near down fusion line. No2 defect is continuing 100mm and depth is 26—32mm, defect is near down fusion line. No3/No4/No5 is shorter defect.

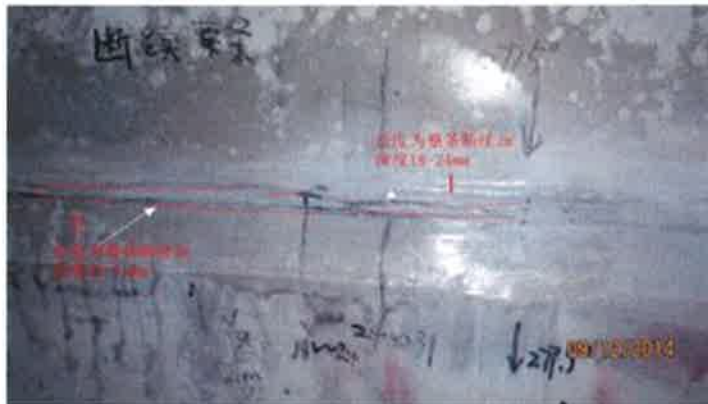
RX0/RX0 11/12 section. 2 cracks were found by UT test, from 265—277.5 degree direction, west of the silo. No1 defect is discontinuing 2000mm length, depth is 18—24mm, location is 10mm from lower fusion line. No2 defect is continuing 2000mm length and depth is 24—31mm, location is near the lower fusion line.

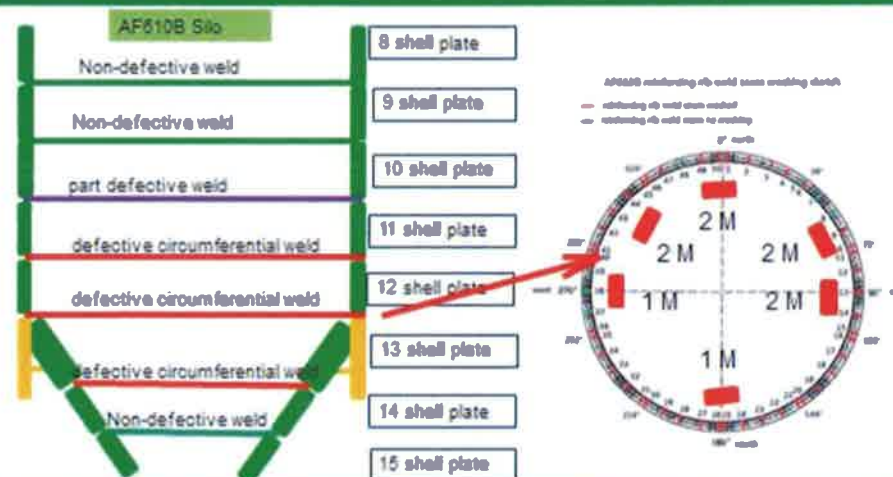
RX0/RX0 12/13 section. the whole circumferential weld seam has obviously cracks by eye. (Ø17000\*14\*83, 323mm length, 32283) width is 2mm. Spot check 10M. Double check of inside and outside by UT on 267.5-277.5 degree, the crack was confirmed through penetrating through outside to inside.

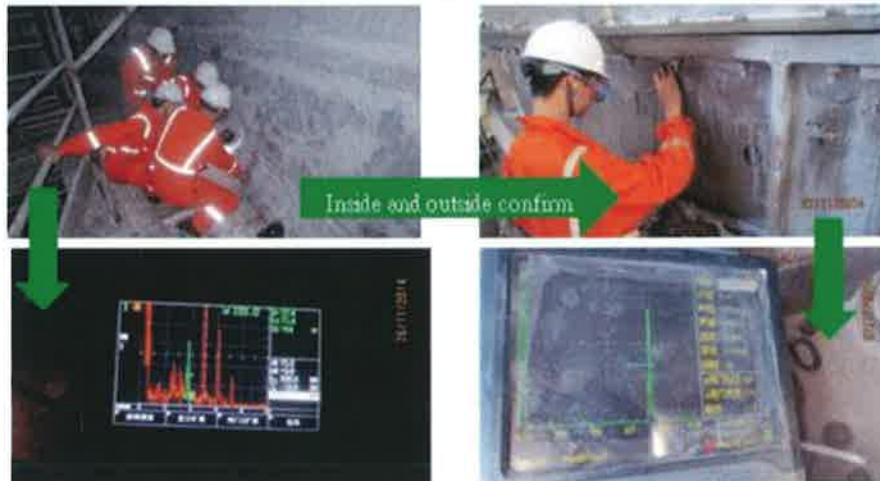
RXII/RXIII 12/13 section: the angle brace weld seam has obviously cracks by eye. D17000\*3, 14+53, 385mm length. biggest width is 2mm. Spot check 10M. Double check of inside and outside by UT on 0-57 3-57 5-105/277 5-237 5 degree. the crack was confirmed through penetrating through outside to inside.

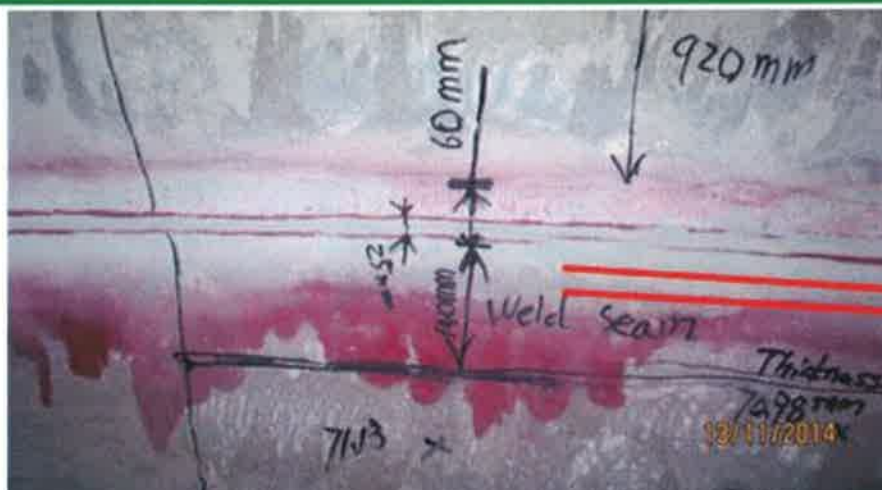
RXII/RXIII 12/13 section: the angle brace weld seam has obviously cracks by eye. D17000\*3, 14+53, 385mm length. biggest width is 2mm. Spot check 10M. Double check of inside and outside by UT on 0-57 3-57 5-105/277 5-237 5 degree. the crack was confirmed through penetrating through outside to inside.

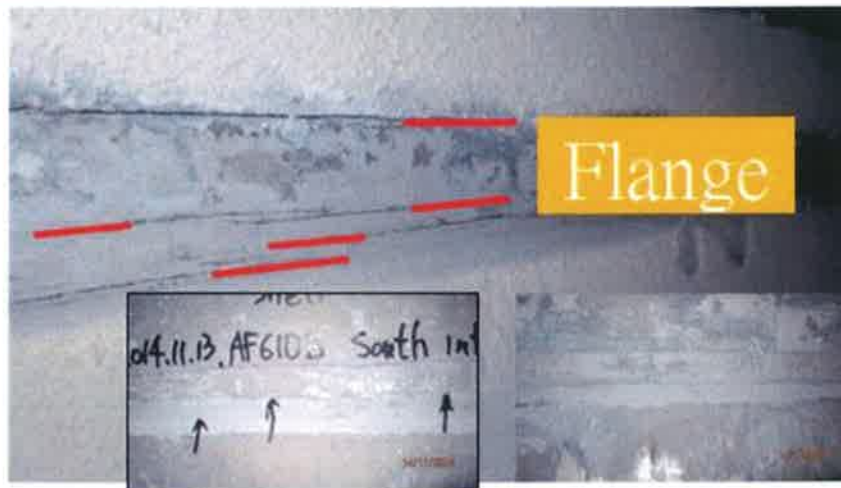
RXIII/RXIII 12/13 section: the whole circle weld seam has obviously cracks. 321700073 14451 339mm length, biggest width is 2mm. Double check of inside and outside by UT on 3/57.5/97.5/180/277.5/327.5 degree, the crack was confirmed through penetrating through outside to inside.

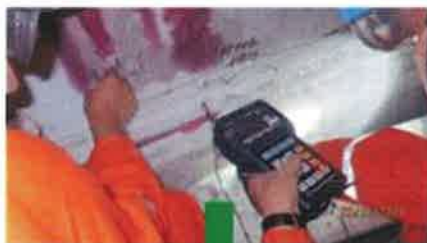
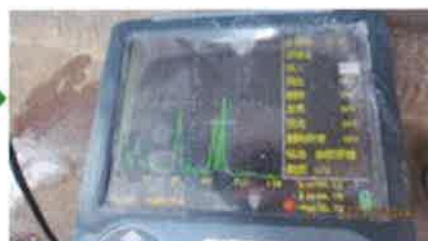
RXIII/RXIII 12/13 section: the whole circle weld seam has obviously cracks by eye. 321700073 14451 339mm length, biggest width is 2mm. Spot check 10M. Double check of inside and outside by UT on 3/57.5/97.5/180/277.5/327.5 degree, the crack was confirmed through penetrating through outside to inside.

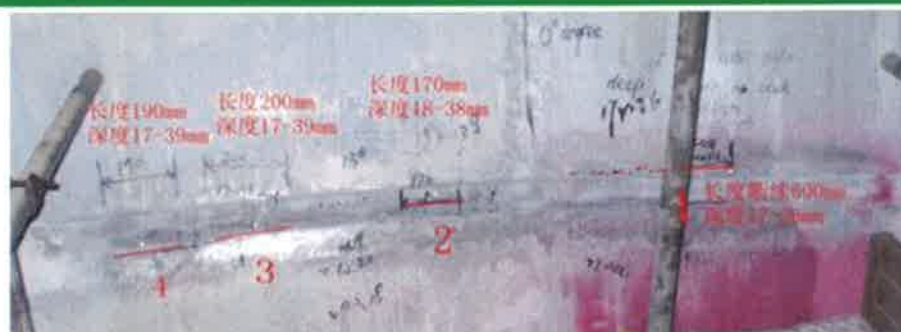
RXIII/RXIV 13/14 section: discontinuing cracks were found by UT test as marked in red location, from 350-360-7.5 degree direction, north of the silo. The depth is about 17-39mm from internal surface, defect is near upper fusion line, continuing length is 600/170/200/190mm

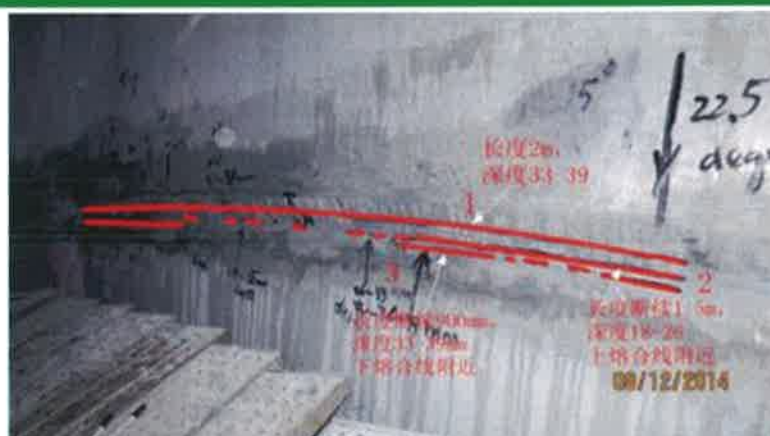
RXIII/RXIV 13/14 section: continuing cracks were found by UT test as marked in red location, from 7.5-22.5 degree direction, north of the silo. The depth is about 18-26mm and 30-39mm from internal surface, defect is near upper and lower fusion line, continuing length is 2000mm, it is severe crack

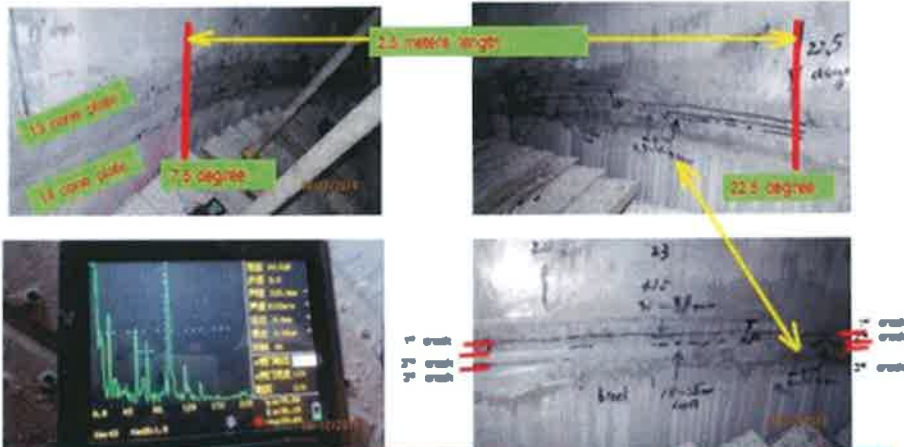
PW/PTX 13/14 section many complex cracks were found in 2000mm length by UT test, from 7.5 to 22.5 degree direction, north of the slip. Total have 3 layer cracks, 1st crack layer continuing length is 2000mm, depth is about 10—15mm. 2nd crack layer is breaking, depth is 20—33mm from the internal surface, the length is continuing 750mm/breaking 300mm/discontinuous 500mm/continuing 440mm. The 3rd crack layer is breaking and discontinuing 2000mm, depth is 33—35mm. The most serious cracks depth is in 14mm area.

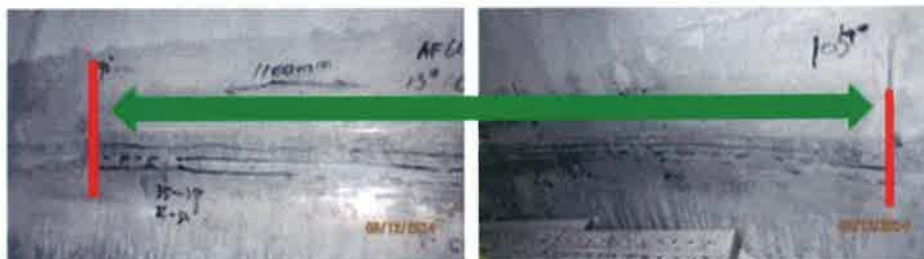
RX/RX 13/14 section many complex cracks were found in 1500mm length by UT test, from 90—97.5—105 degree direction, east of the slip. The depth is about 25—35mm from internal surface, defect is near upper fusion line, continuing length is about 1500mm.

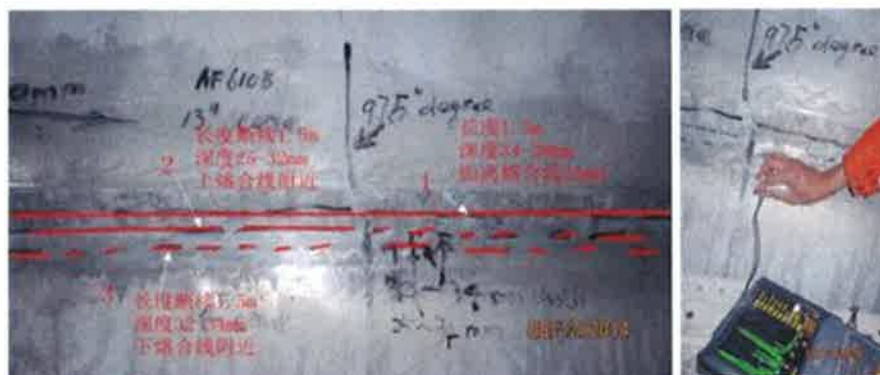
RX/RXII 13/14 section: many complex cracks were found in 1500mm length by UT test, from 90—97.5—105 degree direction, east of the silo. The depth is about 25—30mm from internal surface, defect is near upper fusion line, continuing length is about 1500mm.

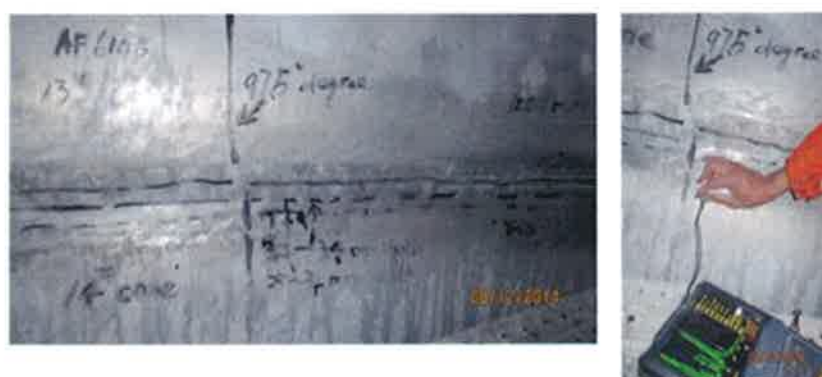
RX/RXIV 13/14 section: many complex cracks were found in 2000mm length by UT test from 90—97.5—105 degree direction, east of the silo. Similar with 7.5 degree defect, total have 3 layer cracks, 1st crack layer is continuing, depth is about 30—39mm. 2nd crack layer is breaking, depth is 32—37mm from the internal surface. The 3rd crack layer is breaking and discontinuing, depth is 24—32mm.

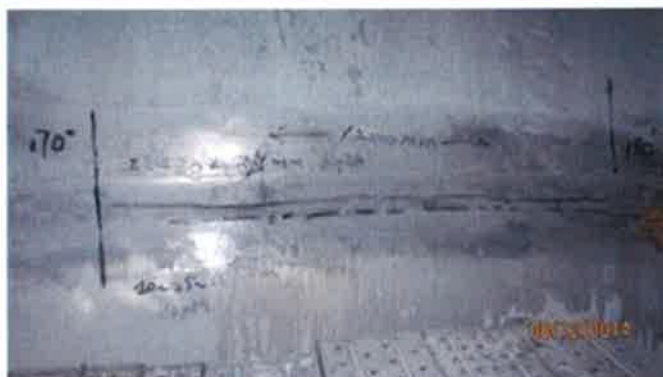
RXMRXIV 13/14 section: 2 complex cracks were found in 1200mm length by UT test, from 170 to 180 degree direction, south of the silo. Similar with 7.5 degree defect total have 2 layer cracks. 1st crack layer is continuing, depth is about 28—35mm, length is 1200mm. 2nd crack layer is breaking and discontinuing, depth is 20—26mm from the internal surface, location is near the upper fusion line, length is 1200mm.

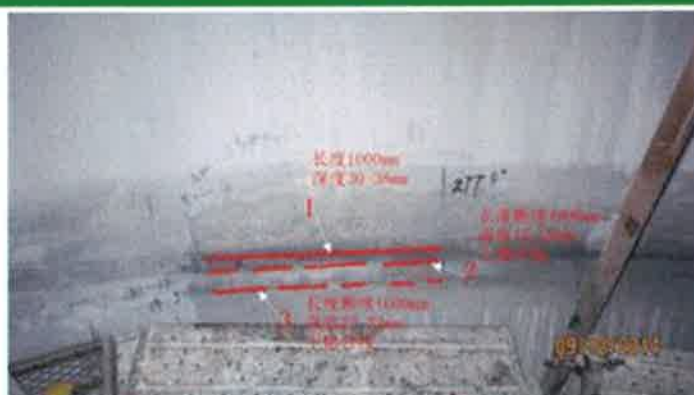
RXMRXIV 13/14 section: 3 complex cracks were found in 1000mm length by UT test, from 270—277.5—280 degree direction, west of the silo. Similar with 7.5 degree defect total have 3 layer cracks. 1st crack layer is continuing, depth is about 30—38mm, length is 1000mm. 2nd crack layer is breaking and discontinuing, depth is 18—25mm from the internal surface, length is 1000mm. 3rd crack layer is breaking and discontinuing, depth is 25—32mm from the internal surface.

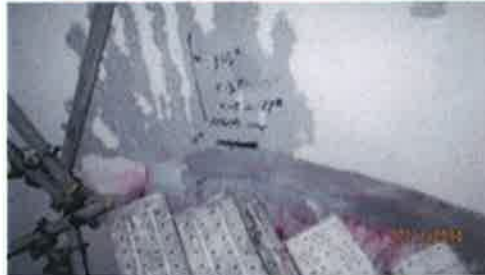
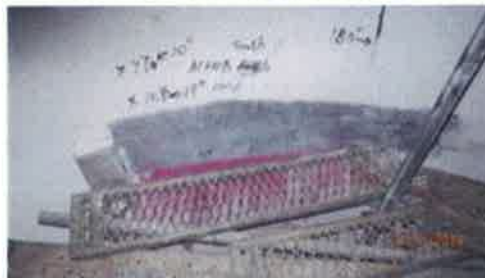
RXIV/RXX 14-20  
section : NO  
defect finding .

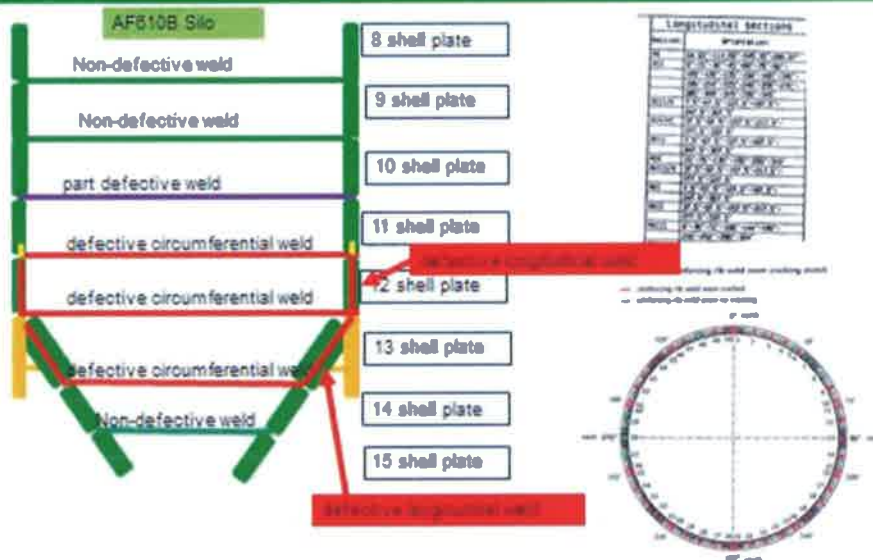
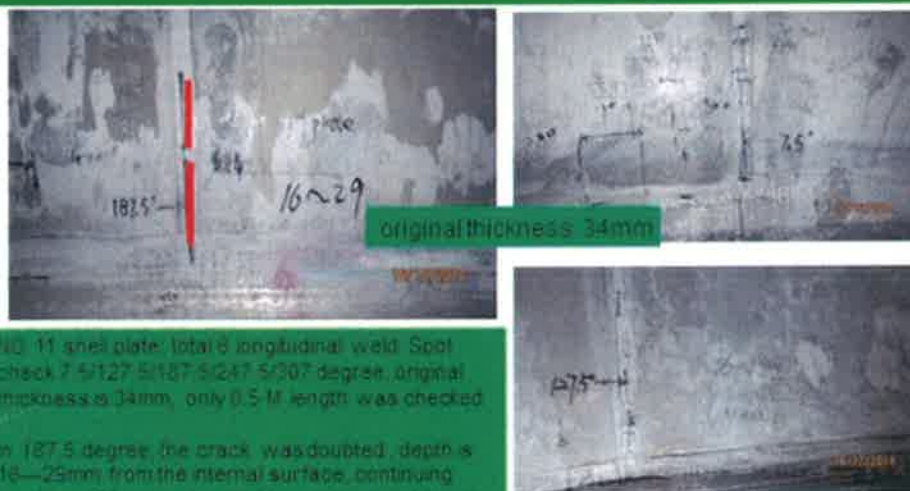
NO. 11 steel plate, total 6 longitudinal weld. Spot check 7.5/127.5/187.5/247.5/307 degree, original thickness is 34mm, only 0.5-M length was checked in 187.5 degree, the crack was doubted, depth is 18—25mm from the internal surface, continuing length is 450mm, not sure if it was crack out. It was confirmed a defect in 7.5/127.5 degree, the defect was slight.

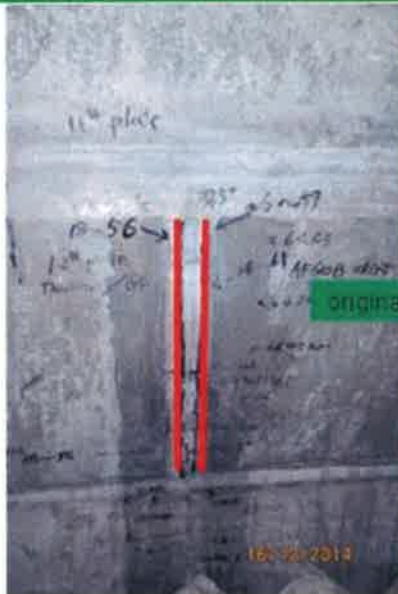
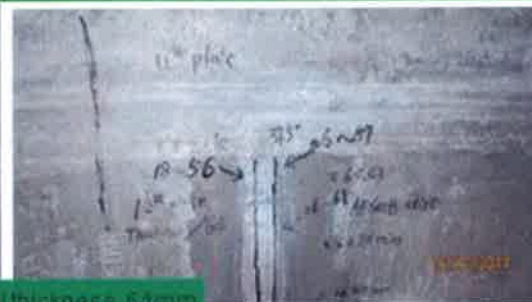
original thickness 64mm

NO 12 shell plate total 5 longitudinal weld  
Spot check 37.5/97.5/157.5 degree, the  
crack was found and the depth is 18—  
58mm from the internal surface, original  
thickness is 64mm the crack is continuing  
or breaking, length 900mm.

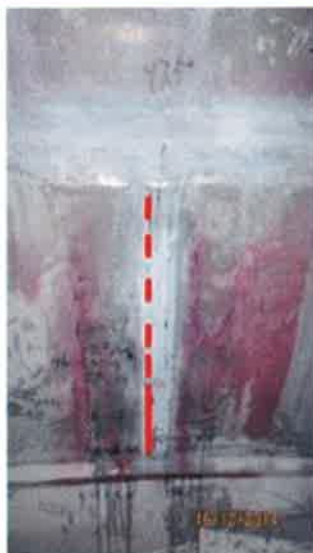
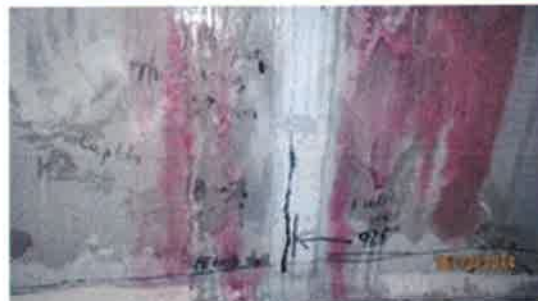
NO 12 shell plate total 5 longitudinal weld  
Spot check 37.5/97.5/157.5 degree, the  
crack was found and the depth is 18—  
58mm from the internal surface, original  
thickness is 64mm the crack is continuing  
or breaking, length 900mm.

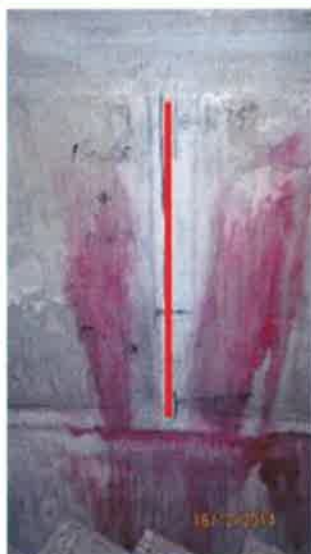
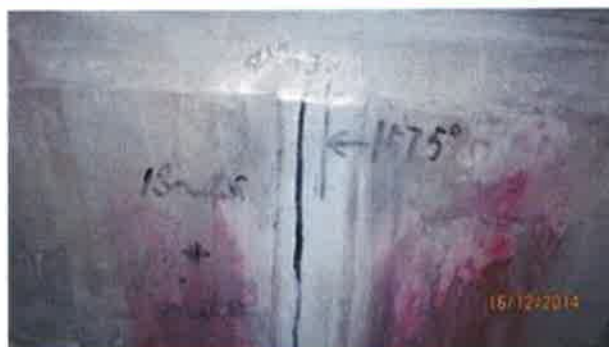
NO 12 shell plate, total 8 longitudinal weld  
Spot check 37.5/97.5/157.5 degree, the  
crack was found and the depth is 18—  
58mm from the internal surface, original  
thickness is 64mm, the crack is continuing  
or breaking, length 900mm.

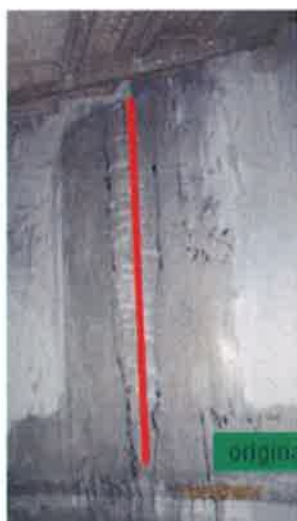
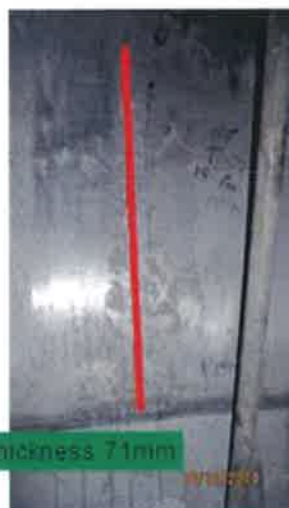
original thickness 71mm

NO 13 cone plate, total  
10 longitudinal weld  
Spot check 0/36/180  
degree, original  
thickness is 71mm, the  
crack was found and  
the depth is 19—64mm  
from the internal  
surface, continuing  
length is 2000mm.

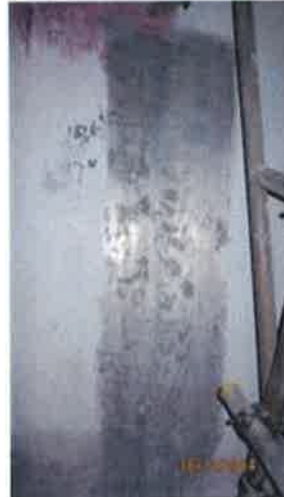
NO 8 shell plate: only 1 longitudinal weld can be checked in 187.5 degree, no defect was found.

NO 17 cone plate: only 1 longitudinal weld can be checked in 187.5 degree, no defect was found.

The other shell plate was not checked because of limited scaffold platform.
