中美和公司台中廠興建計畫  
環境影響說明書申請備查內容  
(新建備用成品儲槽)

開發單位：中美和石油化學股份有限公司  
中 華 民 國 1 0 6 年 1 2 月

# CAPCO TCP Product Silo Inspection Report

# AF610B PTA Product Silo Internal Inspection report

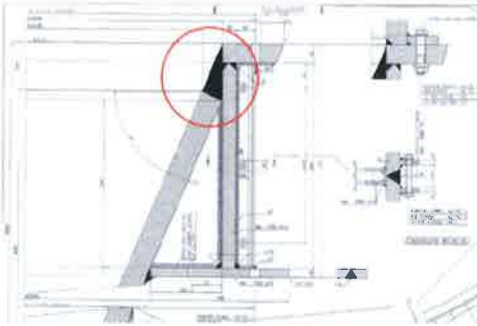
- DWG of manufacturer J&D

- There were leakage and weld seam crack finding at "a" position before TAR. It was very likely the weld seam "b" had crack already.
- This job scope is focus on weld seam "b" inspection and repair.

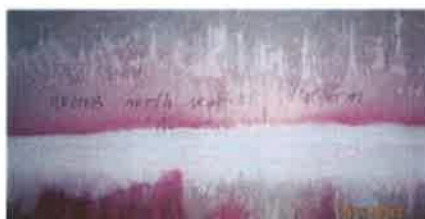
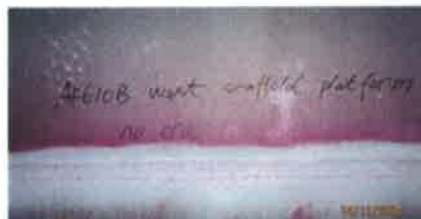
RX/RMI shell plate joint circumferential weld were checked by PT. No cracks and other defect were found by random check, 4 \* 2000mm, 4 scaffold platform, 4 directions, east/south/west/north, 90/180/270/350 degree.

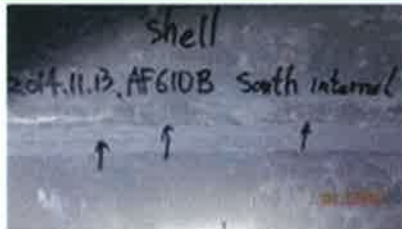
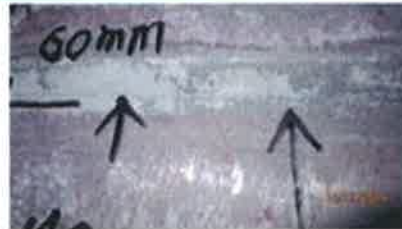
Crack length: RXII/RXIII shell plate joint circumferential weld were checked. The whole circle has cracks,  $\phi 17000 \times 14=53,389 \text{mm}$  length.

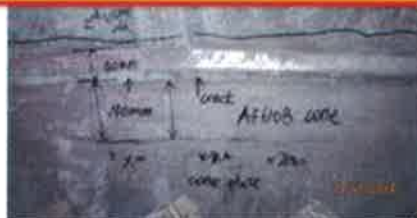
Condition of the 2nd longitudinal weld(RXII/RXIII) section : no cracks were found in vertical weld, but circumferential weld is in whole section cracks.

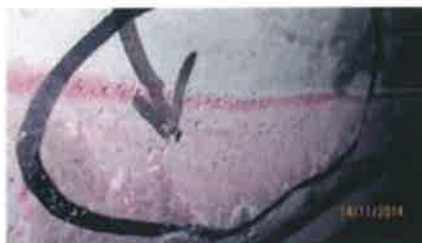
AF010B  
pitting

5.85 mm  
depth

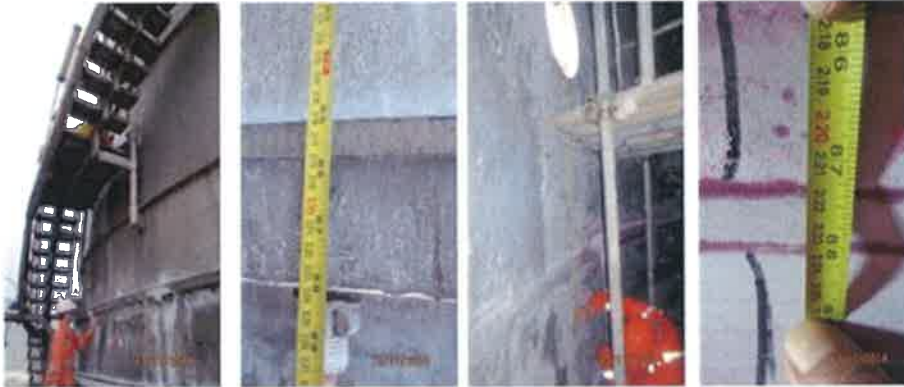
Calculate and identify the internal location of flange

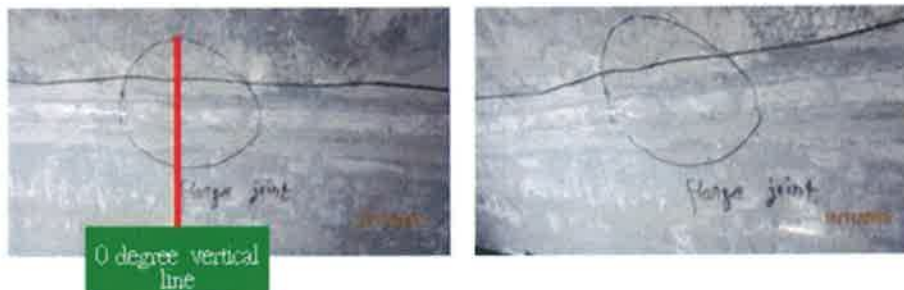
Other finding: flange joint is not plain and smooth, but big curve

5. Other finding, flange vertical levels not in the same line and big curve. Flange joint is not plain and smooth, but big curve.

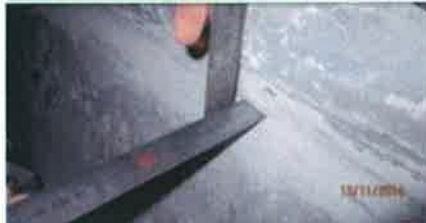
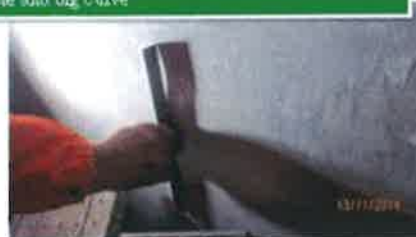
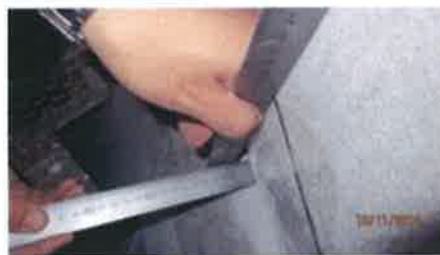
Other finding: flange vertical level is not in the same line and big curve

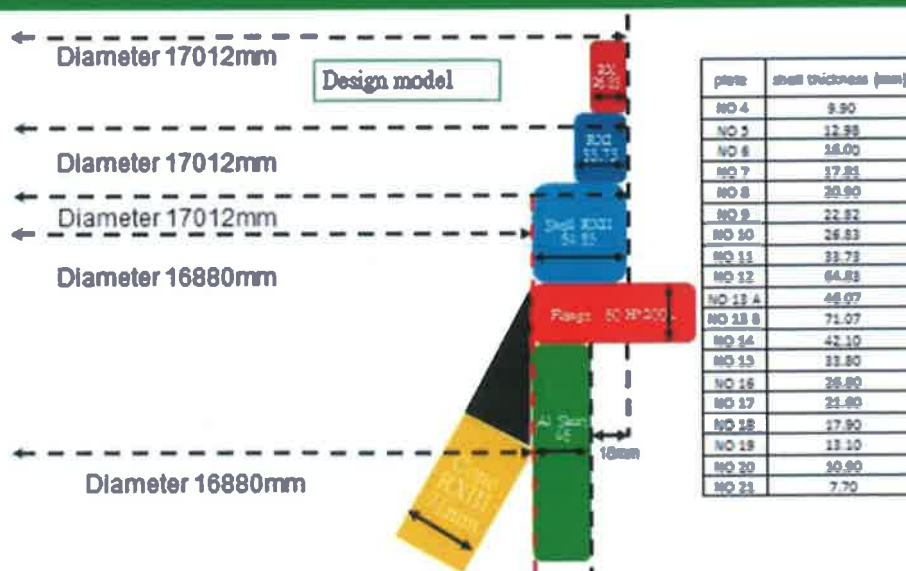
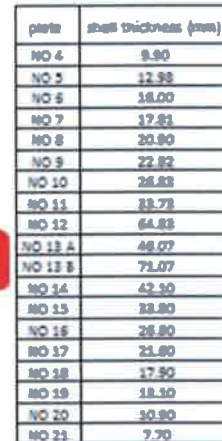
1. Shell plate thickness is in normal condition.
2. RX/RXI shell plate joint circumferential weld were checked by PT, No cracks and other defect were found by random check, 4\*200mm, 4 scaffold platform service, 4 directions, east/south/west/north, in 90°/180°/270°/350 degree.

3. RX/RXII shell plate joint circumferential weld were checked by PT, focus on "T" weld, The only 200mm length crack was found on north-eastern direction, about 67.5 degree. Many pitting were also found in circumferential weld, which is 650mm and 1400mm length in the circle of 157.5 degree and 187.5 degree.
